The Morton Effect

and Light Rubs in Rotating Machinery

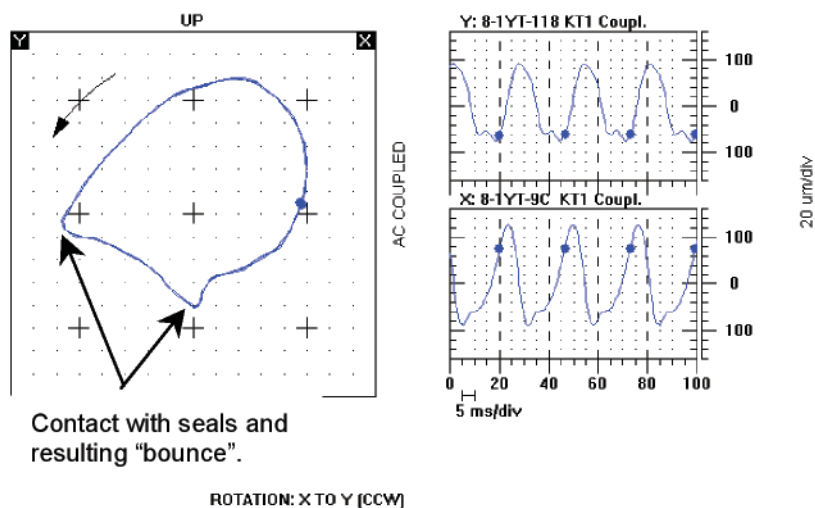
Figure 2 – Shaft orbit plot from a mechanical drive steam turbine experiencing a seal rub.

and orbital motion is constrained. Figure 2 shows an orbit obtained from a machine experiencing a seal rub. One can readily see the portion of the orbit where the rub is occurring as the shaft “bounces” away from the contact location. Visual examination of the seals later confirmed the diagnosis, as rub tracks were evident on both the shaft and the seal.

[Editor’s Note: If Figure 2 looks familiar, that’s because it also appears in the case history on pages 34–43 in this issue of ORBIT. Please refer to that article for photographs of both the shaft and seal surfaces, which were taken during visual inspection to confirm that a rub was indeed occurring.]

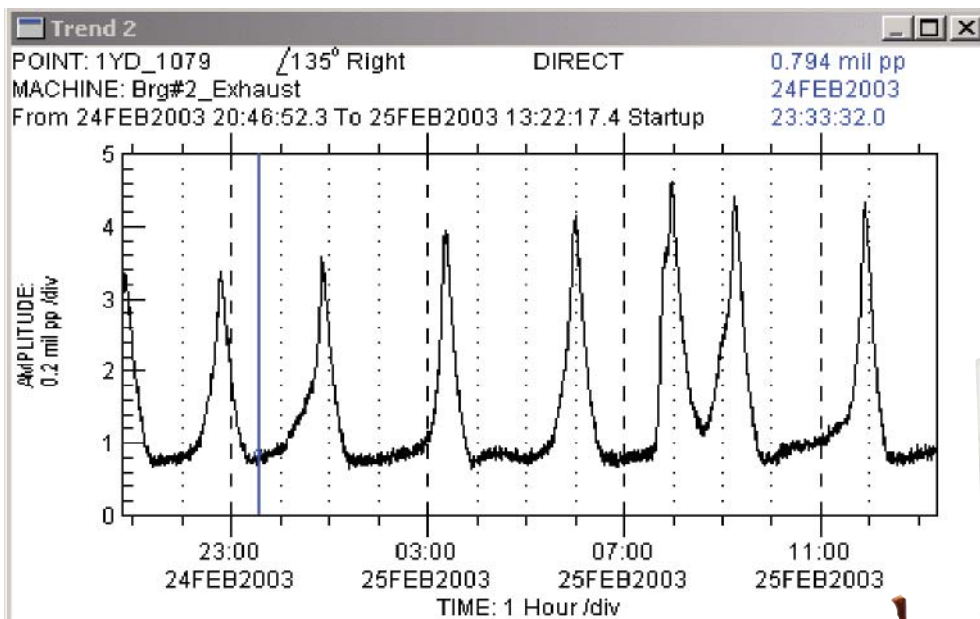
Figure 3 – Trend plot showing cyclic amplitude oscillations resulting from a light rub. The vibration reaches a peak approximately every 2-3 hours and then temporarily subsides again.

Figure 3 was obtained during a field machinery diagnostics job conducted by the author and shows the amplitude trend plot collected from a gas turbine experiencing a light rub during steady-state base load conditions. The trend plot shows the classic cyclic behavior discussed earlier, where the amplitude alternately increases and then decreases. In this instance, however, the rub-initiating mechanism turned out to be unrelated to load. It was found that the machine had a leaky oil seal. As the oil leaked, it would slowly heat until it became hardened (i.e., formed coke) and continue to build up until a rub ensued. The coke would be abraded away through the rubbing action until the rub disappeared, but the leaking oil would form more coke and the cycle would repeat itself.

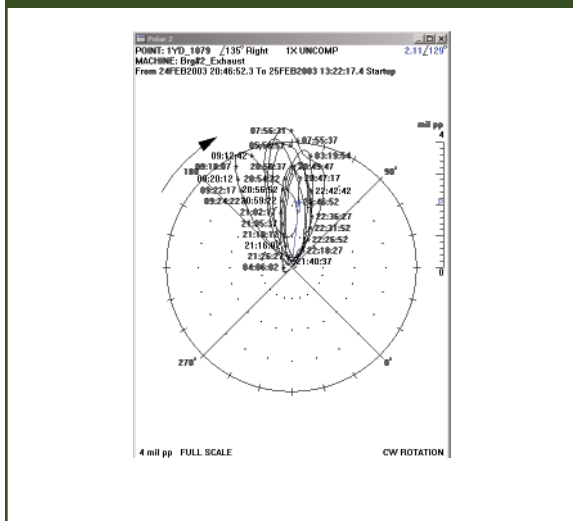
Figure 4 – Polar plot from the same probe location as Figure 3, showing non-linear (non-repeatable) vibration and phase response. Such response is typical of a light rub.

The polar plot of Figure 4 illustrates this non-linearity quite dramatically and is taken from the same machine and proximity probe as the trend plot of Figure 3. The “loops” in the polar plot are indicative of changes in both amplitude and phase, but notice that these changes do not “retrace” themselves from one cycle to the next.

supporting oil-film wedge in the bearing) remains highly steady as well. Consequently, the “hot spot” on the shaft remains in the same location. As the machine undergoes its cyclic changes in amplitude and phase due to the repetitions of the shaft bowing and then relaxing, the stationary location of the hot spot results in changes in amplitude and phase that are so repeatable as to trace nearly the same pattern on the polar plot from one cycle to the next. This is shown in Figure 6. Compare this response with the non-linearity (non-repeatability) of the response for an actual light rub condition as shown in Figure 4.

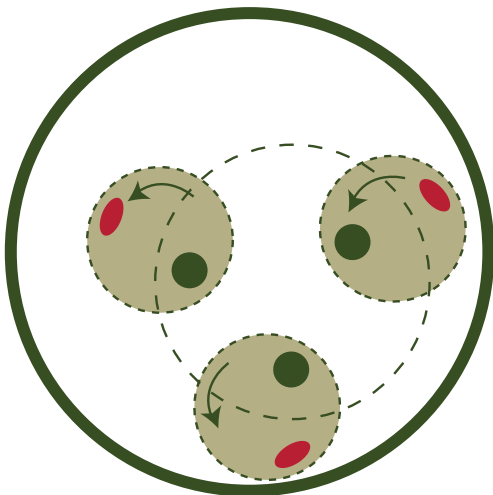
Figure 5 – The Morton Effect. Under certain conditions, the shear stresses in the bearing lubricant can be sufficiently large to create localized heating on the rotor, causing it to bow.

To understand how the Morton Effect occurs, refer to Figure 5. Here, it is assumed that the dominant force acting on the machine is residual unbalance, and that the bearing stiffness is symmetrical about the centerline. This results in predominantly synchronous (1X) vibration with a largely circular orbit as the shaft vibrates within its bearing clearance. Vibration of this form orients the rotor surface in the same position each time it rotates as long as loading and speed remain constant. This means that the same segment of the rotor’s circumference will always be subject to the minimum clearance (the red spot on the rotor in Figure 5) while another segment of the rotor’s circumference will always be subject to the maximum clearance (the black spot on the rotor in Figure 5). Although this condition creates a thermal gradient instead of a uniform heat distribution about the rotor’s circumference, unless the

shear stresses are suitably large, the gradient will not be large enough to result in a shaft bow. However, when the shear stresses are sufficiently large, the heating effect is appreciable and the shaft bows, just as if a rub was occurring at the location of minimum oil film thickness. As a result, the 1X vibration amplitude increases.

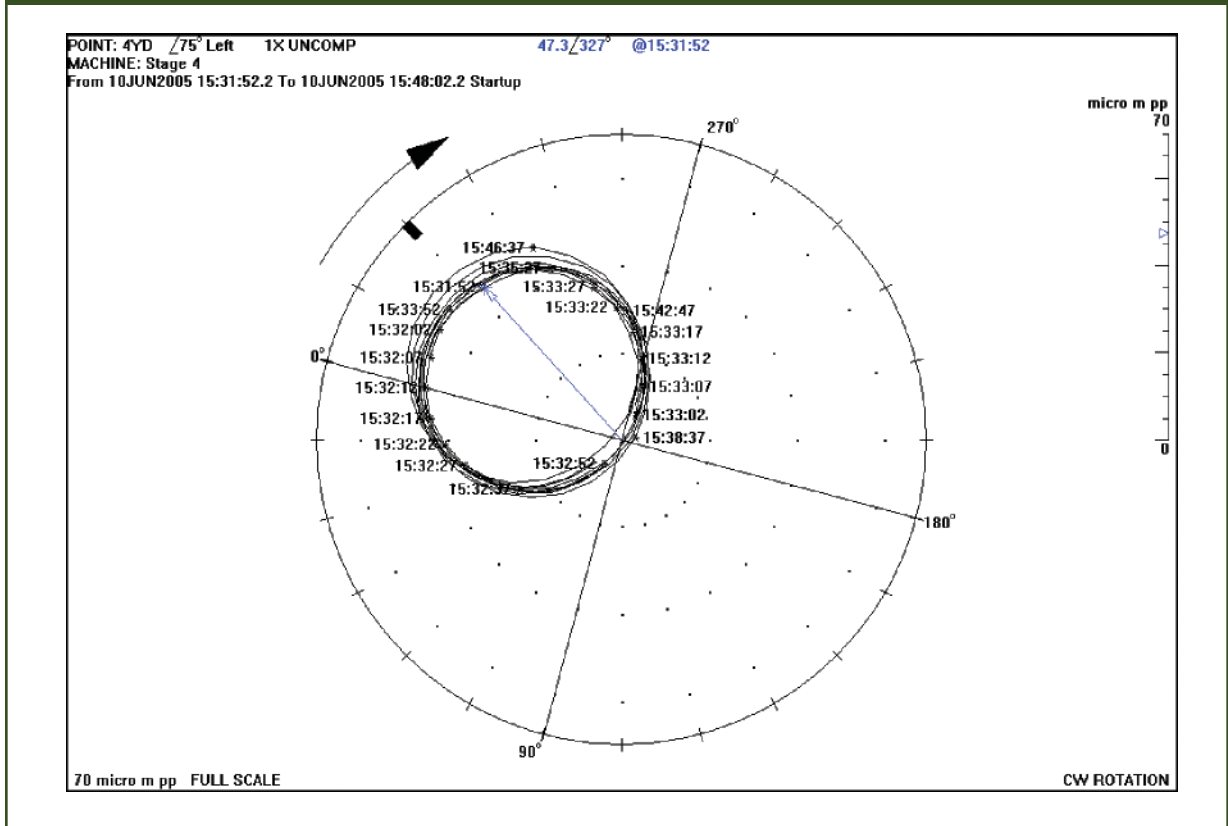
Figure 6 – Polar plot showing evidence of the Morton Effect as noted by the highly repeatable changes in amplitude and phase during each limit cycle.

As part of the a machinery diagnostics job carried out by the author on the machine used for Figures 6 and 7, criteria A, B, and D were met. Both repeatable loops and spiral vibration patterns were observed in polar plots from the machine, depending on speed fluctuations and loading conditions. Changes to the lube oil temperature were conducted and corresponding changes to the amplitude and periodicity of the magnitude trend was observed. The machine was reasonably heavily loaded. And, the machine was an integrally geared air compressor where the impeller was overhung from a high-speed pinion. Combined, these factors pointed strongly towards the Morton Effect as the underlying cause of the elevated vibration levels. The operator was advised to avoid certain lube oil temp ranges and machine loading conditions until a more permanent remedy could be applied.
