Liquid Cooled Generator – Stator Winding Connection Ring Test, Repair and Upgrades

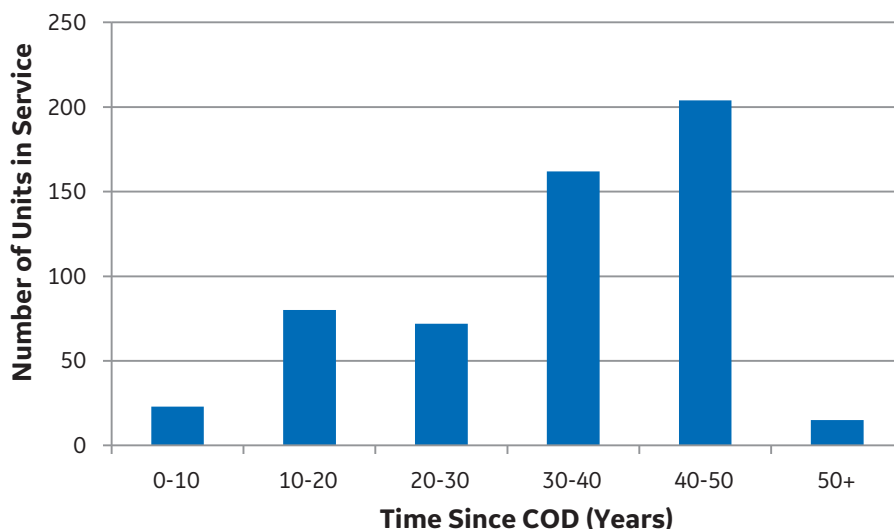
Figure 1 Generator Age

The average age of a large liquid cooled GE generator is now over 35 years and many owners plan to run them for many more years. Large liquid cooled generators were designed for decades of life with expected periodic inspection, maintenance and repairs. For example, field rewinds and stator rewinds have been routine refurbishments over the years.

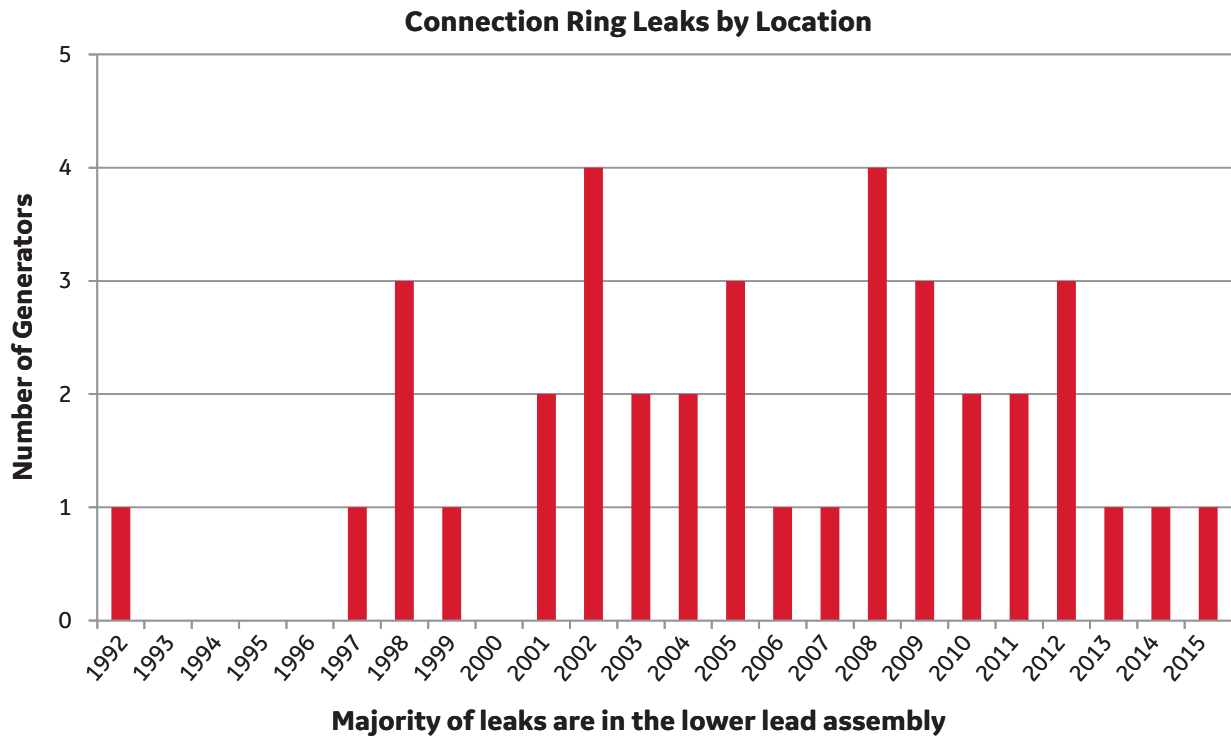
Figure 2 Connection Ring Leaks by Location

To help customers perform risk assessment GE has compiled data on the connection ring leaks, as shown in Figure 2. This shows the number and location of leaks. This is data we are aware of at the time of this document and it is reasonable to expect this number will continue to grow.

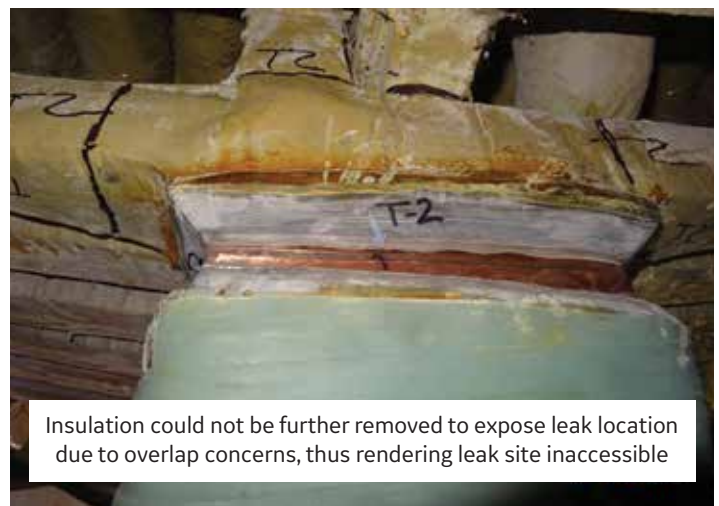
Figure 9. Inaccessible Connection Ring Leak

GE has experienced a case (2012) of a Connection Ring Leak that was not accessible for repair. See Figure 9 for a typical view. This type of leak presents a difficult customer risk decision in regards to pursuing a repair solution or operating the unit as is and monitoring the leak. A repair solution for an inaccessible leak would entail removal of the connection ring from the end winding with the stator winding in-place. This removal process would be highly intrusive and would require disassembly of the hose, phase connections, connection ring support system and flexible leads.

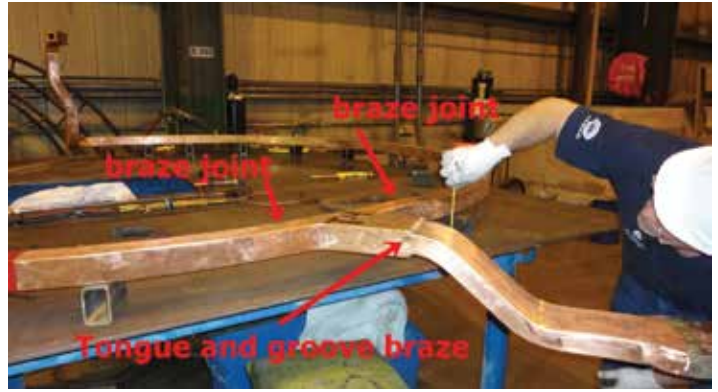
GE also can remove the existing connection rings and refurbish them by stripping the existing insulation, re-flowing the manufacturing assembly brazes and re-insulating at the GE Schenectady manufacturing plant. Reference Figure 10. This refurbishment process resets the insulation and braze integrity

Figure 10. Typical Connection Ring Refurbishment

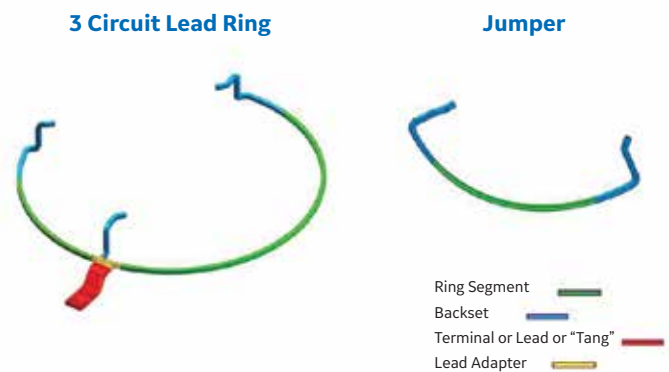
A more complex ring, designed for a 3 circuit generator winding is shown in Figure 12. This ring is comprised of two main ring sections which span at least ½ of the circumference, 3 backset sections which attach to the 3 circuits, and finally the terminal which attaches to a high voltage bushing.

Figure 12. 3 Circuit Lead Ring and Jumper

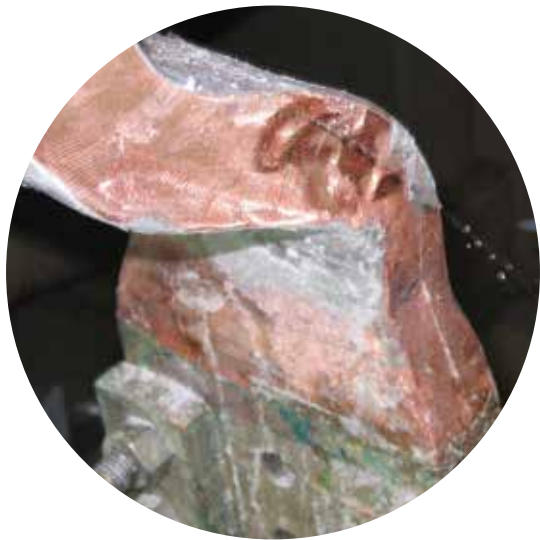
Manufacturers have joined copper components for large steam turbine-generator stator winding connection rings with various filler metals, but primarily with copper, silver, and phosphorus-containing braze alloys. This family of alloys has been user-friendly for brazing copper components in factory environments, without a flux or without particular positioning to contain the alloy and prevent run-out. These braze alloys continue to be widely used in the industry. When used to join copper components that come in contact with cooling water in directly water-cooled stator windings, phosphorus-containing braze alloys are prone to accelerated corrosion mechanisms that can lead to eventual water leakage. Connection ring water leaks can degrade high-voltage insulation on the connection rings, result in stator winding hydraulic leakage (HIT SKID) test failures during test and inspection outages or after full stator rewinds, and extend test, inspection, and refurbishment outages to repair the leaks. The root cause of the corrosion has been identified as the presence of phosphorus in the braze alloy. Reference Figure 17.

Figure 17. Connection ring braze joint water leak identified during on-site test and inspection

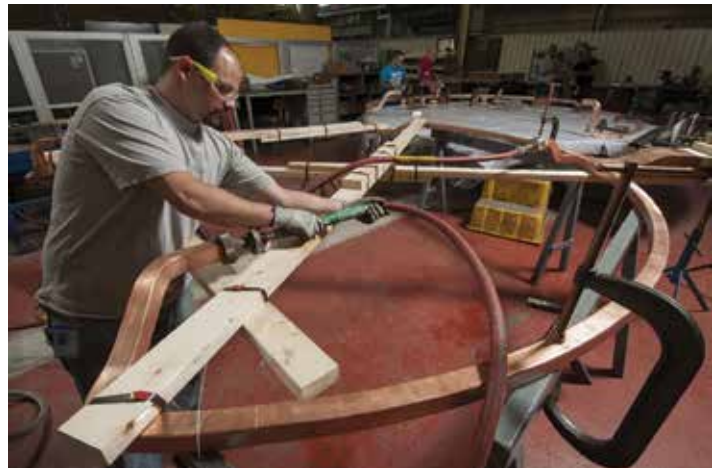
Figure 24. Connection ring brazing workstations

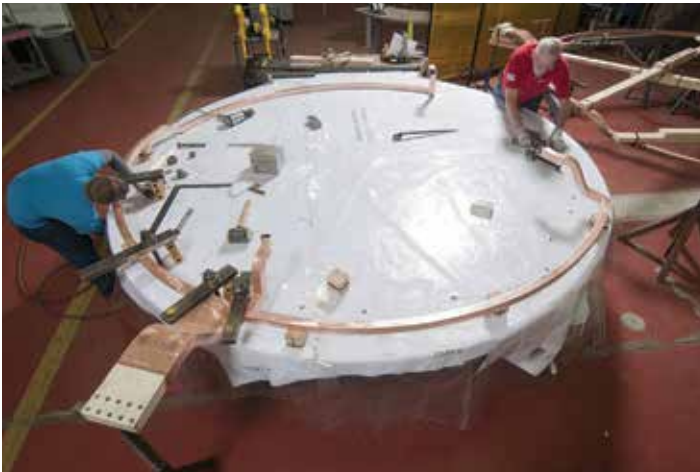
GE completed the first shipment of phosphorus-free brazed connection rings (Reference Figure 25) in 2014 and the connection rings were installed during a full stator rewind and placed into service in 2015.

Figure 25. Phos-free liquid-cooled connection rings
